HELICOPTER SECONDARY STRUCTURES
RELIABILITY AND MAINTAINABILITY
INVESTIGATION

Kaman Aerospace Corporation

January 1974

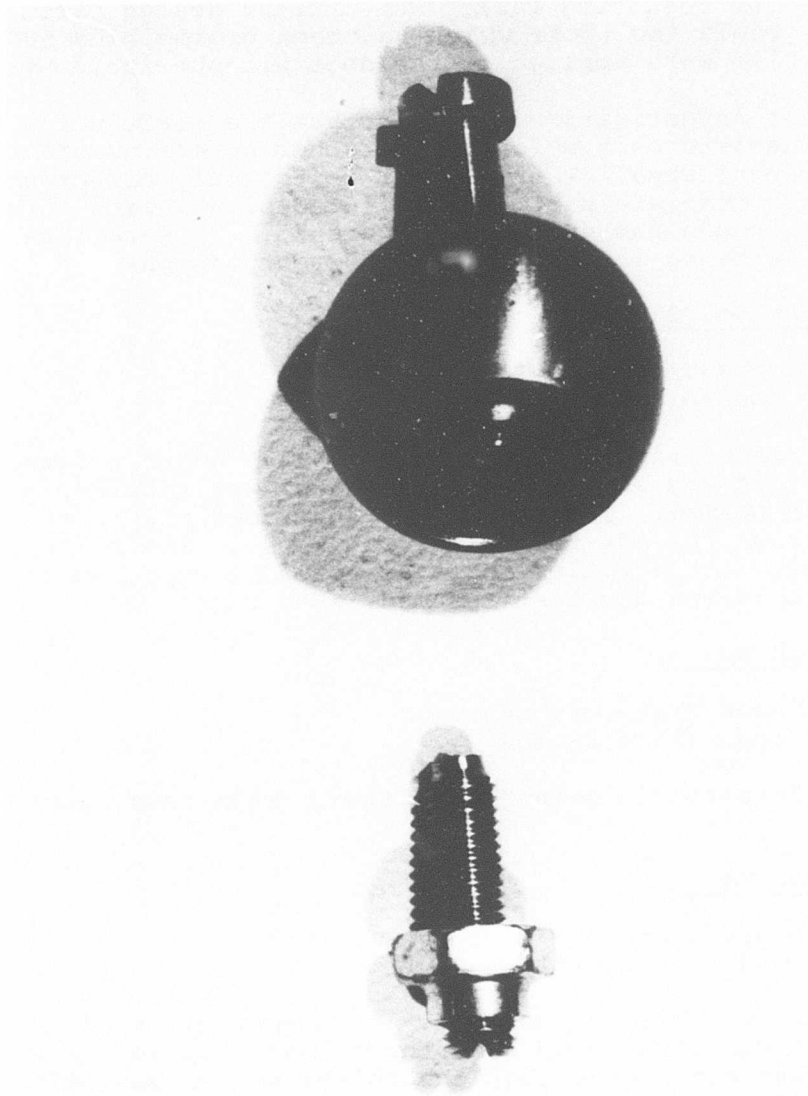
During the open-close cycling, the aft upper roller shaft broke on the 88th cycle. This permitted the door to move aft past the stop and to become disengaged from the tracks. The aft lower roller support bracket, which is a casting, was fractured in the resulting fall. New current design parts were installed, replacing those which had been broken, and 500 open-close cycles were applied to the door without incident.

Figure 7. Failure of Undercut Roller Shaft on Pilot Rescue Door.

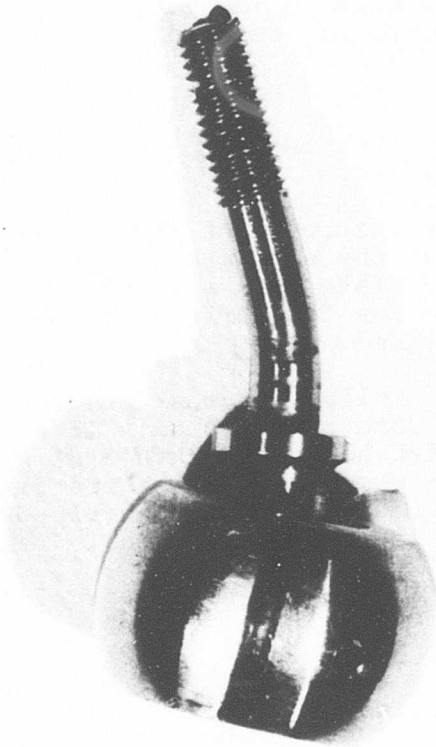
At the beginning of the open-close cycling for this test block, considerable resistance was encountered to door motion. The upper rollers were disassembled, and it was found that the forward roller had such a large flat spot that it would no longer roll (Figure 9). The aft roller had several large spots (Figure 8), its roller shaft was severely bent (Figure 8), and its spacer showed considerable deformation (Figure 11).

Figure 8. Bent Roller Shaft and Flat Areas on Upper
Aft Roller on Pilot Rescue Door.

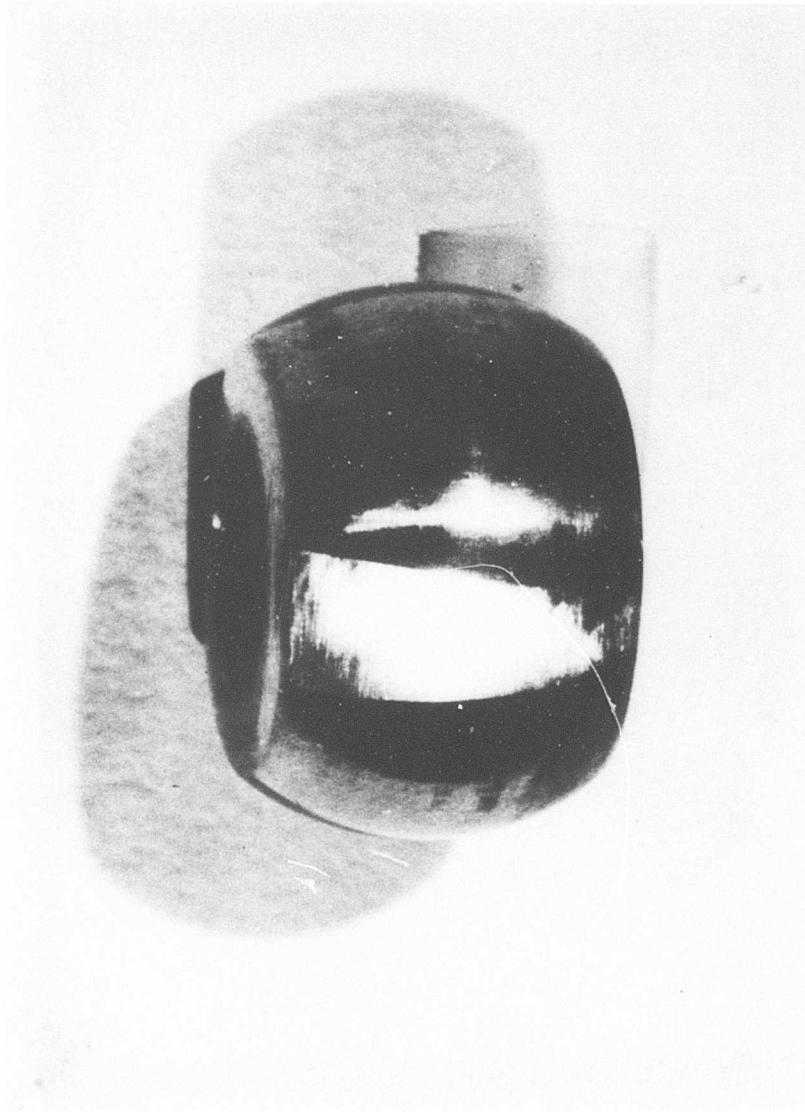
Figure 9. Large Flat Area on Upper Forward Roller.

Initially, upon inspection of the roller housings, it was very surprising that such large flat-spotting (Figure 9) could be inflicted upon these steel housings with no corresponding wear in the aluminum alloy tracks. The evidences of wear on the tracks were barely discernible except for the area where the spacer had contacted the edge of the track lip. On the inner contour of the track, the wear patterns were minor depressions, perhaps .002" deep. However, upon reflection, it became evident that the mode of wear was fretting between the steel housing and the aluminum track. One of the common compounds formed in the fretting of aluminum is aluminum oxide, which is an excellent abrasive medium. The fretting compounds formed in the fretting of steels are nowhere near as hard as the aluminum oxide, and so the steel component wears away. There was no evidence of looseness of the "UNIBAL" insert within the roller housing nor of degradation of the insert as compared to a new component.

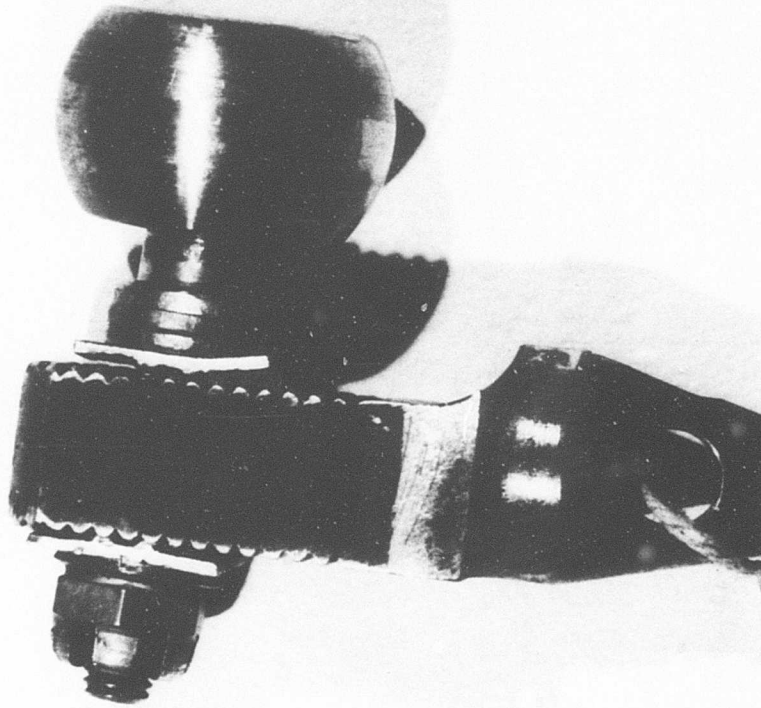
Figure 10. Upper Aft Roller Assembly Showing Deformation of Serrated Washer and Wear Pattern on Roller.

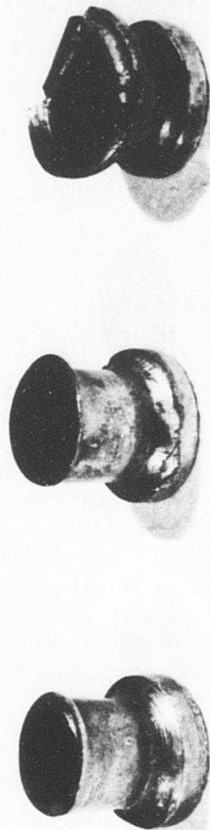
Figure 11. Progression of Failure in Roller Spacer.

In consonance with normal field procedure, these components were replaced with the exception of the spacer, for which an NAS-75-3-10 bushing was substituted for the reason noted in Test Block No. 5 above.

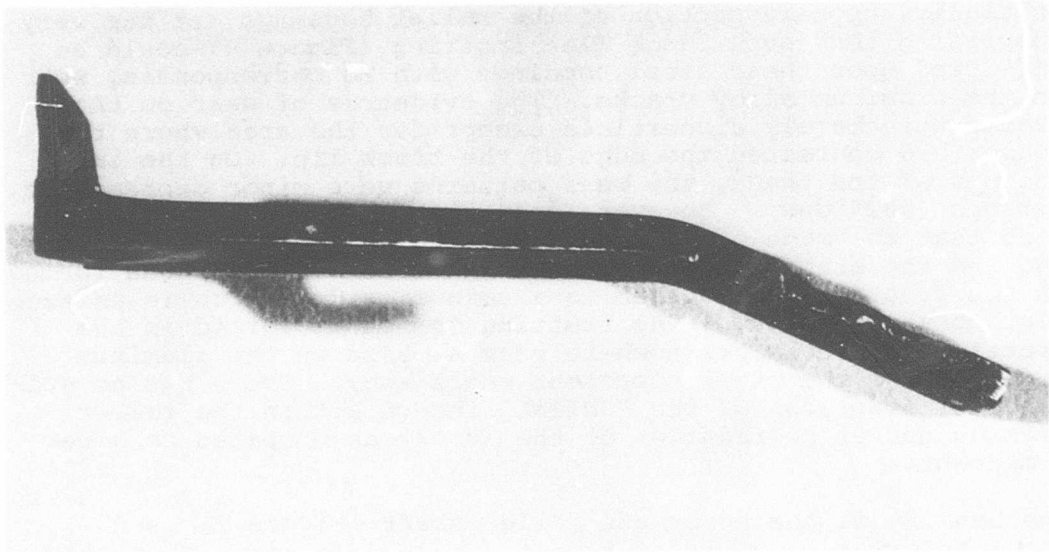
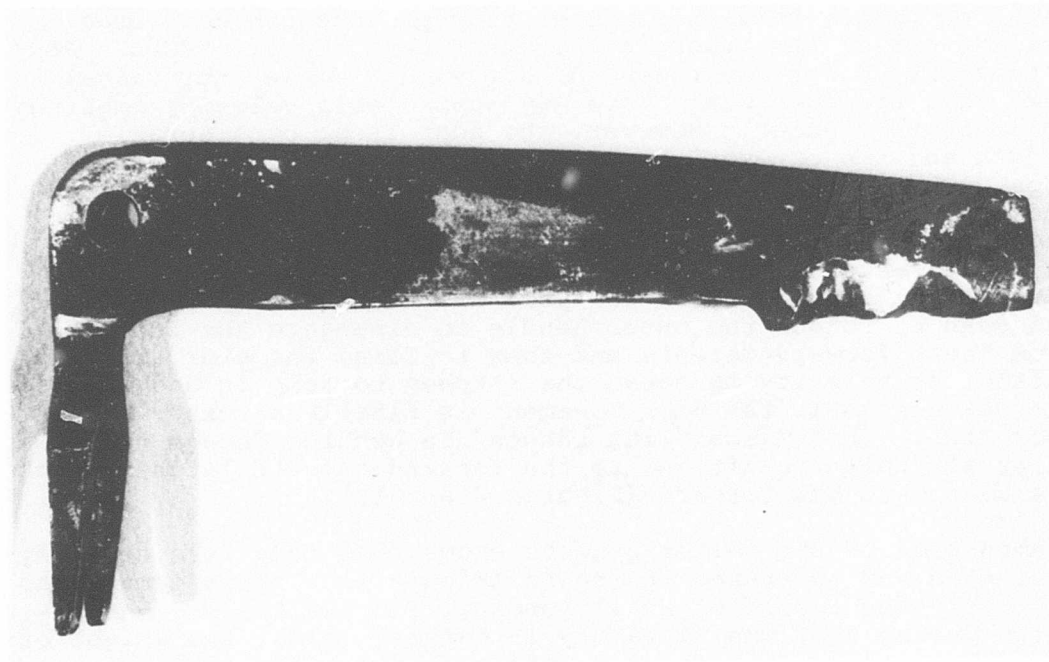
Figure 12. Two Views Showing Damage to Aft Latch
on Pilot Rescue Door.

A defect which was not specifically mentioned in the operational data analysis but which showed up in the current design test program was deformation of the door latches (Figure 12). It was evident that the deformation was caused by the latches' striking their detent plates as they moved past them during the open/close cycling of the door. This is another instance of impact damage, which again invokes proposed new design criterion No. 4 for its solution.

The current design latches are flat steel plate sections, and in order to strengthen them, they were converted to Tee-section configurations by welding a cross-bar to their outer vertical edges. The modified latches are shown in Figures 17 and 18.

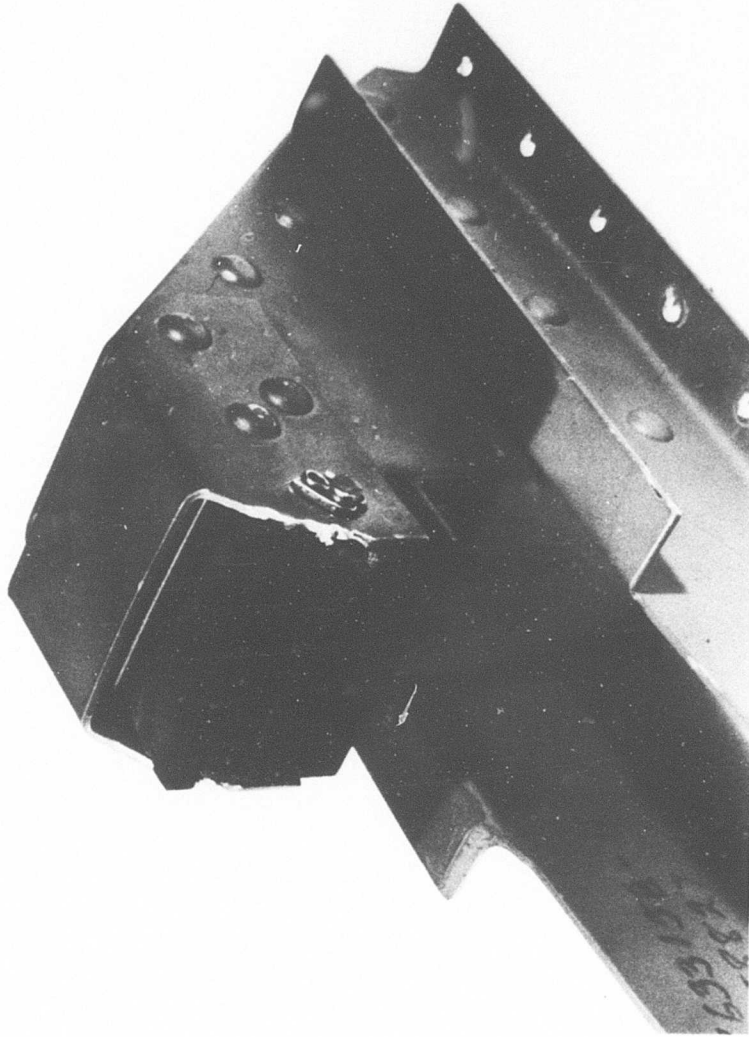
Figure 14. Detail Showing Damage Sustained by New Door Stop.

1. Door striker plate was bowed outboard from the door (but still operative) (Figure 16).
2. The aft upper roller had several minute flat spots. However, these flat spots were not of sufficient size to impair the operation of the door (Figure 19).
3. The sheet-metal fairing on the aft edge of the door had suffered some minor impact damage as a result of (1) above (Figure 16).
4. The plates supporting the rubber bumper on the new door stop had minor impact damage due to a slight discrepancy in waterline heights between the door stop and the door striker plate (Figure 14).

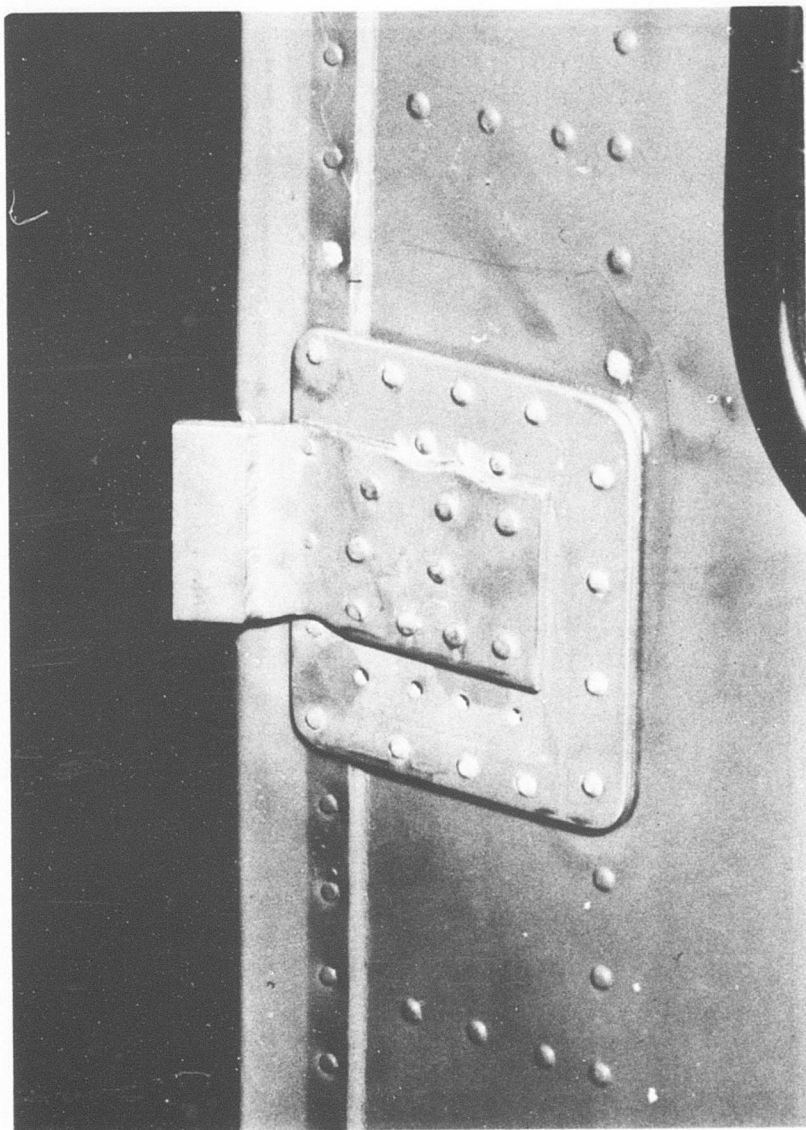
Figure 15. New Design Striker Plate on Aft Edge of Door.

In order to improve the condition on the roller shaft, it was decided to eliminate the cause of the cantilever loadings to which it is subjected in service. This was done by eliminating the door stop from the track and relocating it. Since it was now understood that the door could be expected to be frequently slammed against the stop, its design and location were given careful consideration. It was finally decided to locate the stop at the approximate waterline location of the C.G. of the door. This location minimizes any cocking action experienced by the door upon impact against the stop. The stop structure, which is illustrated in Figure 13, consists of two tapered channel section members located externally on the fuselage in a waterline plane. Located between these channels and attached to their webs is a tapered box-section member with a generous sized rubber bumper attached to it. One of the channels picks up an existing row of intercostal rivets, and an angle-section intercostal was added to provide backup structure for the other channel. A steel striker plate was attached to the stop contact area on the aft edge of the door (Figure 15) to protect the door sheet-metal structure.

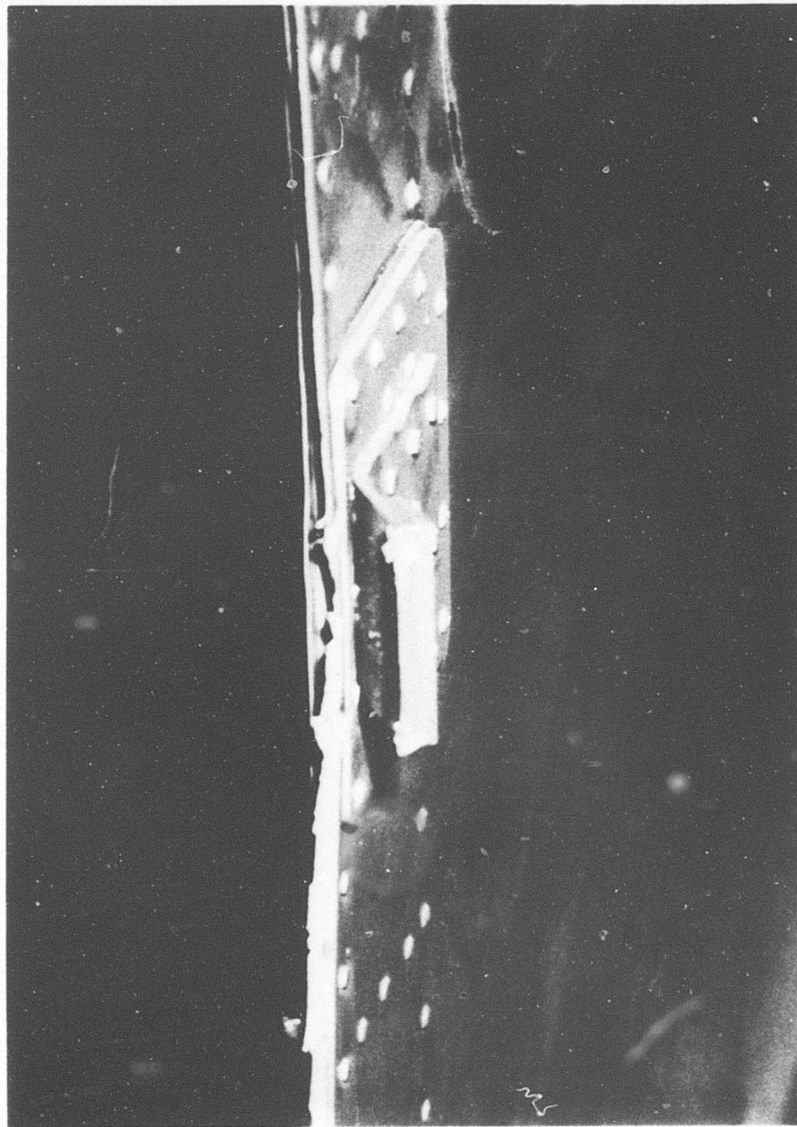
Figure 16. View Showing Deformation of New Striker Plate and Damage to Aft Edge of Door.

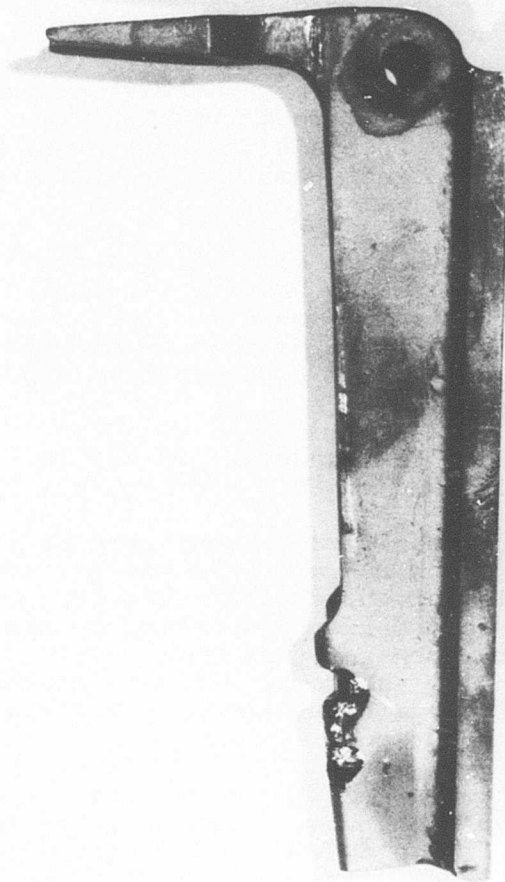
Figure 17. Modified Aft Latch After Test Showing
Local Impact Damage.

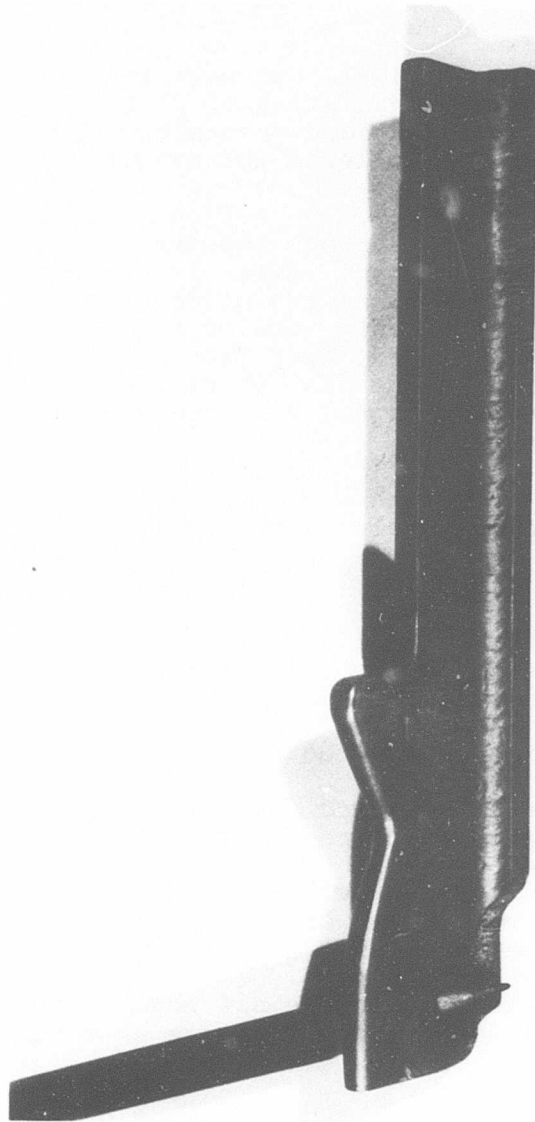
Figure 18. Modified Forward Latch After Test Showing
Local Impact Damage.

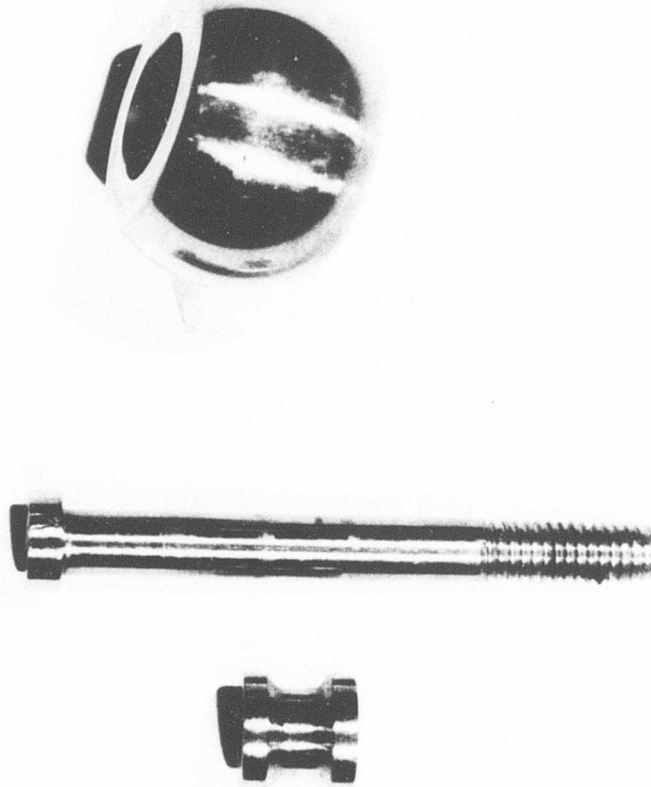
Figure 19. Modified Roller Spacer With Roller Shaft and Bearing Showing Lack of Damage After Test.
